COLORADO CULTURAL RESOURCE SURVEY

Architectural Inventory Form

1. Resource number: **5SM.1583**
2. Temporary resource number: **N/A**
3. County: **San Miguel**
4. City: **Telluride**
5. Historic Building Name: **Unknown**
6. Current Building Name: **Beckman House**
7. Building Address: **557 W. Colorado Avenue**
8. Owner Name and Address: **Mike Beckman
P. O. Box 22000
PMB 241
Telluride, CO 81435**

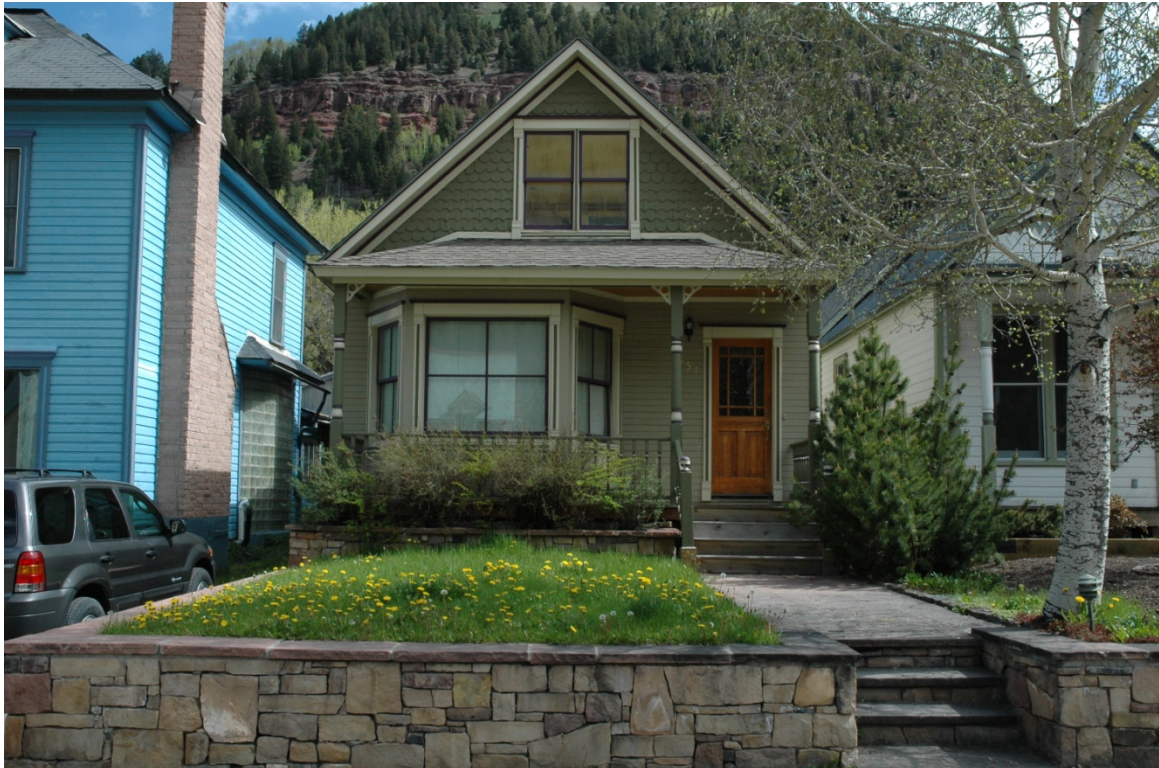
**THLD RATING:****Supporting to District**

21. General architectural description:
This is a 1.5-story historic wood-frame dwelling, with a modern two-story rear addition to the north elevation. The house is supported by an unpainted concrete foundation, and its exterior walls are clad with painted olive green horizontal weatherboard siding, with 1" by 4" corner boards. Variegated patterned wood shingles appear in the façade's upper gable end, however. The front gable roof is covered with brown asphalt composition shingles, and the eaves are boxed with painted cream white wood trim. Two non-historic skylights are located near the south end of the east-facing roof slope; one non-historic skylight is located near the south end of the west-facing roof slope. A non-historic stained brown wood-paneled door, with leaded glass upper sash lights, enters the east end of the façade (south elevation) from a full-width front porch. The porch is approached by four wood steps, and features a tongue-in-groove wood floor, turned columns with brackets, an open wood railing with turned balusters, and a low-pitched hip roof. A large non-historic (circa mid-1980s) canted bay window projects out onto the porch to the west of the entry door. A set of paired 1/1 double-hung sash windows penetrate the façade's upper gable end, overlooking the porch roof. Windows elsewhere on the secondary elevations are also primarily 1/1 double-hung sash, with painted wood frames and surrounds. A set of paired glass-in-wood-frame doors enter into the second story of the addition from a balcony on the north elevation.

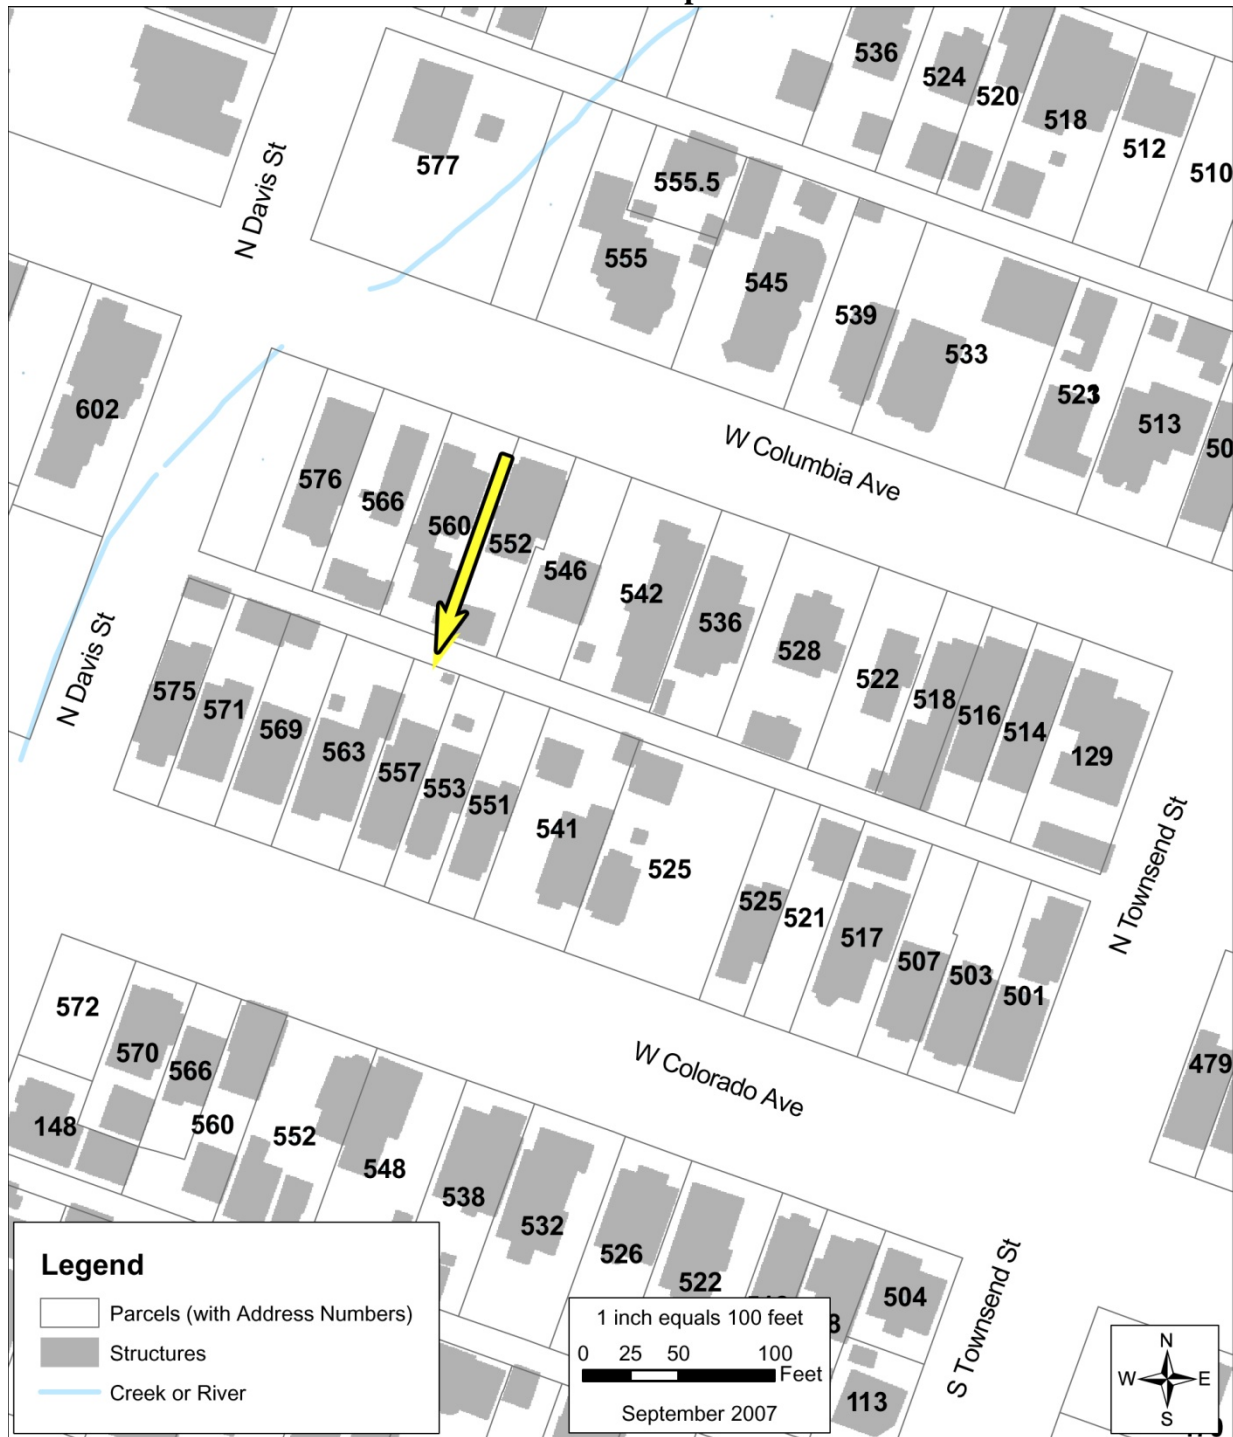
Sketch Map

This property is located on the north side of Colorado Avenue, in the block between Townsend and Davis Streets, near the west end of the Telluride National Historic Landmark District.
